Fire Research Report: The British Oxygen Company Limited,  
150 Polmadie Road, Glasgow, G5

Production and distribution of Medical and Industrial Gases.  
Bulk Liquid Petroleum Gas Storage Terminal.

- (a) A 15 ton capacity Liquefied Petroleum Gas articulated road tanker, Registration number:- WNN 406H.
- (b) Liquefied Petroleum Gas bulk storage terminal consisting of 4 x 100 tons capacity cylindrical welded steel tanks with hemi-spherical ends, measuring 76 feet in length by 12 feet in diameter.

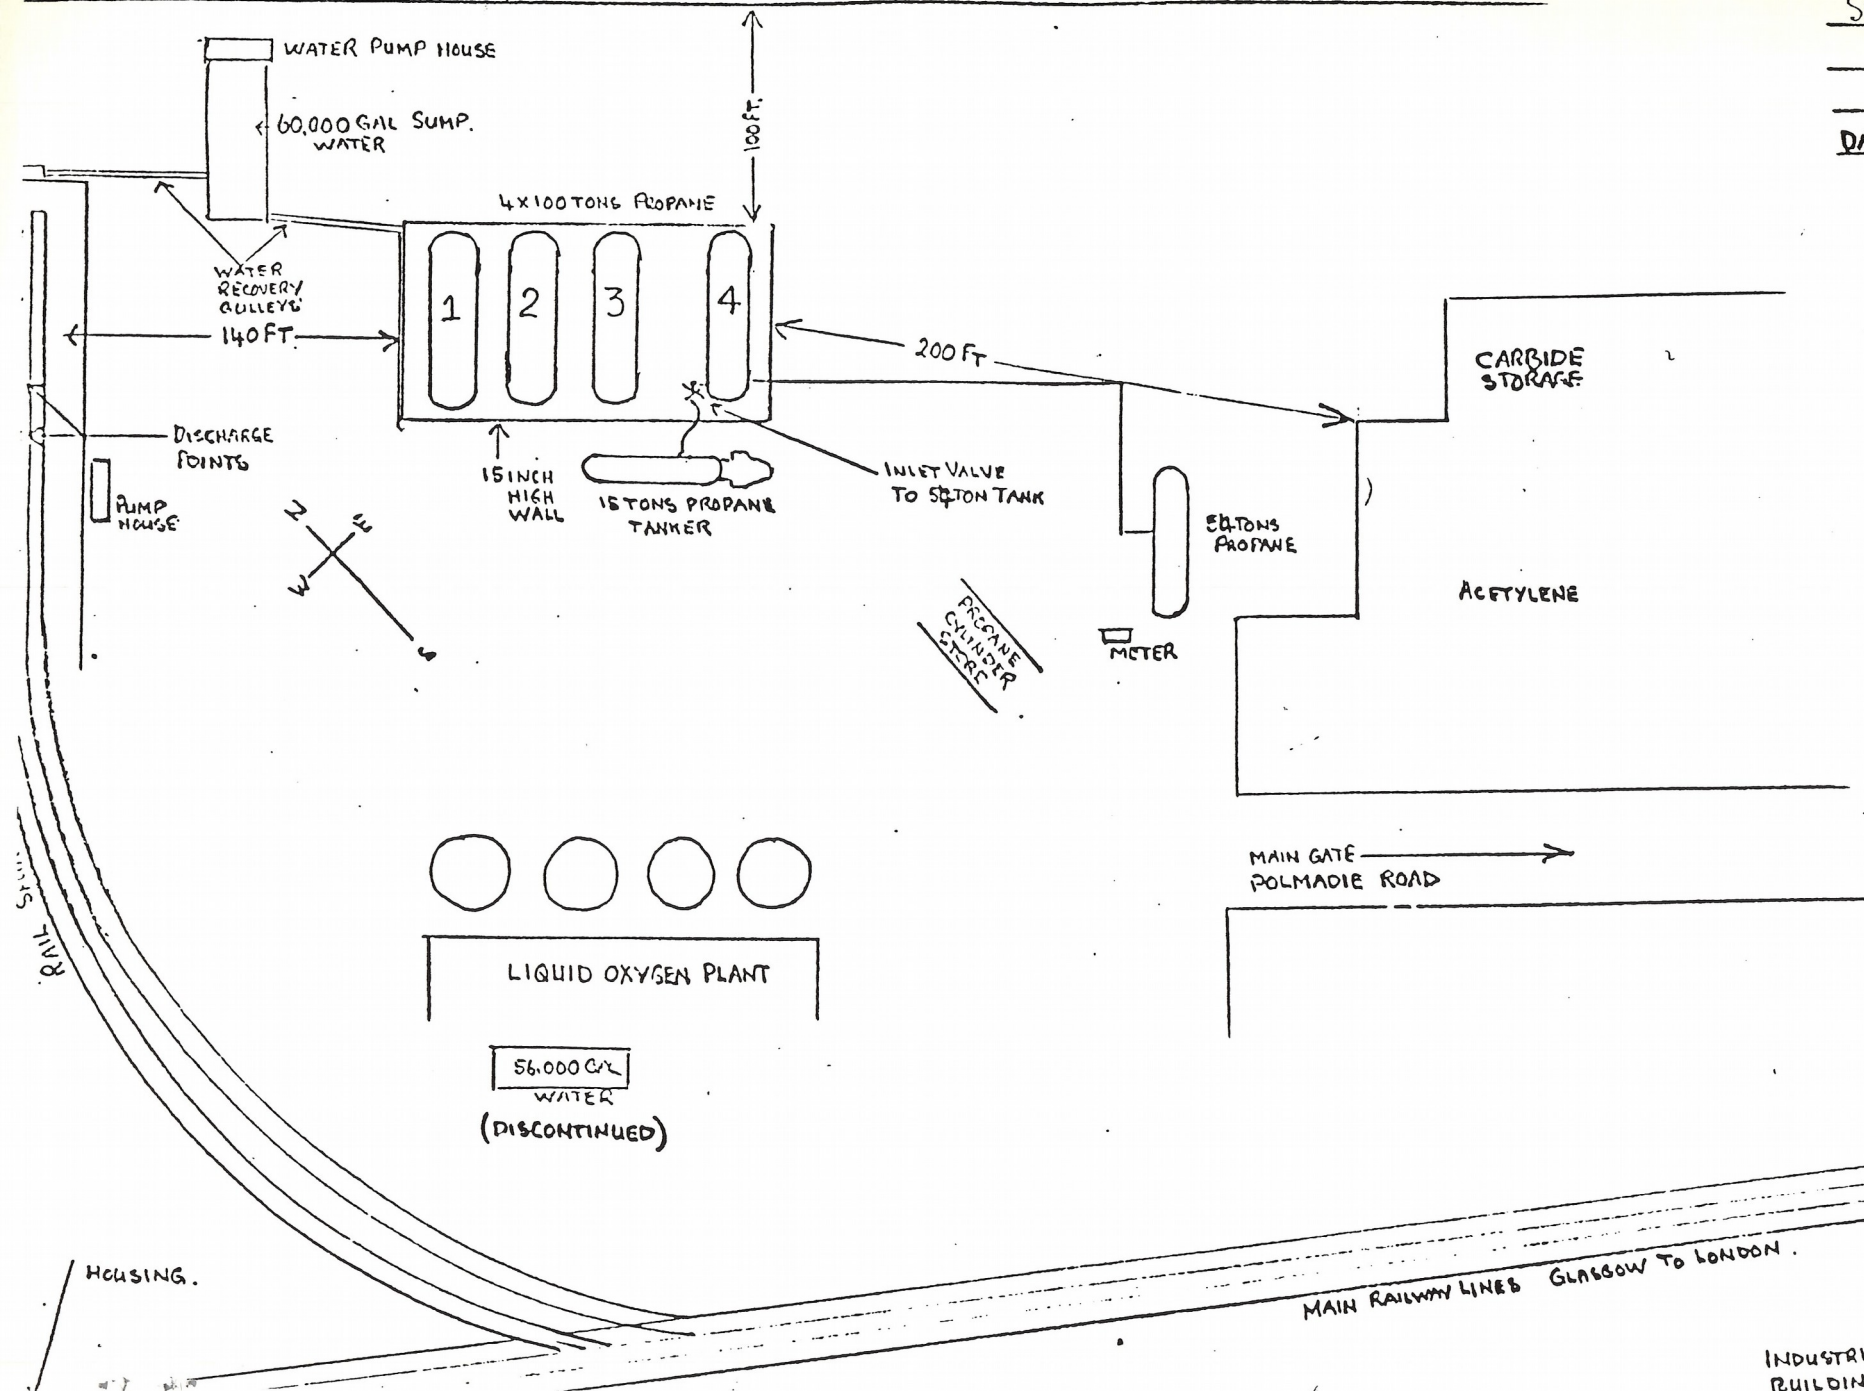
The inlet leading to the remotely sited 54 ton capacity storage tank is located almost immediately below No. 4 storage tank, the tanks being numbered from left to right. (See attached sketch).

The system failed at one vital point. The 'V' threaded blank cap of the three inch water pipe located below No.4 storage tank, immediately above the inlet valve to the 54 ton storage tank had either been left off or was so loosely connected that the force of water along the pipe dislodged it. The impinging jets served by this pipe therefore failed to function properly the water flowing freely from the end of the three inch pipe.

The gas flame from the tanker, partially impeded by the fifteen inch dwarf wall around the installation, enveloped the traction unit, the remainder of the flame impinging on to the lower end of No.4 storage tank and fifty feet along the lower left bottom of the tank. It also enveloped ancillary pipework and valves between Numbers 3 and 4 storage tanks.

The tanker was parked about 15 feet from the ends of the storage tanks with outlets from the tanker facing the ends of the storage tanks. Had the road tanker off-loading point been remote from any storage tanks or had the road tanker been parked in such a manner that the delivery valves were facing away from the storage tanks, then the incident would most probably have been confined to a fire involving the road tanker and its contents only.
